# 926C Lantern Battery – Terminal Issue

# 926C Lantern Battery – Terminal Width out of Specification

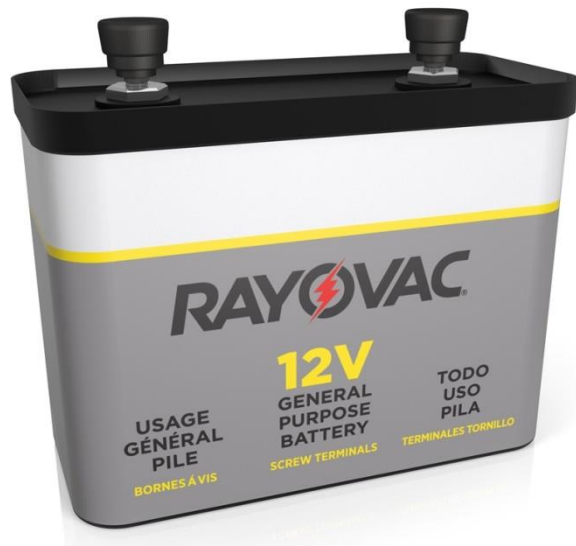
*There is a manufacturing error with the 926C 12V lantern battery. The terminal spacing is approximately .035" too narrow, and will therefore not connect properly in devices that have fixed terminal connections.*

.035" too narrow for fixed terminal connection

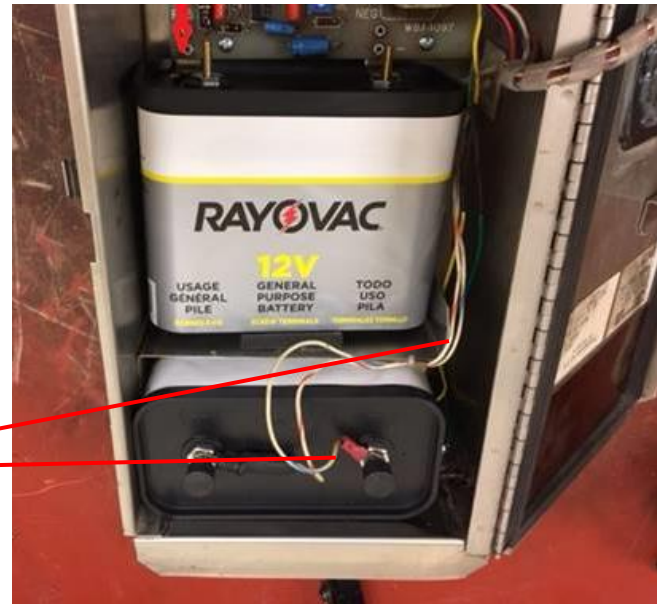
Flexible Connection  
(wire leads with clip)

# Lantern Fixed vs Flexible Connections
